Redbridge Viaduct

Steve Jones of Concrete Repairs Ltd (CRL) looks at current repair works undertaken to Redbridge Viaduct in southern England.

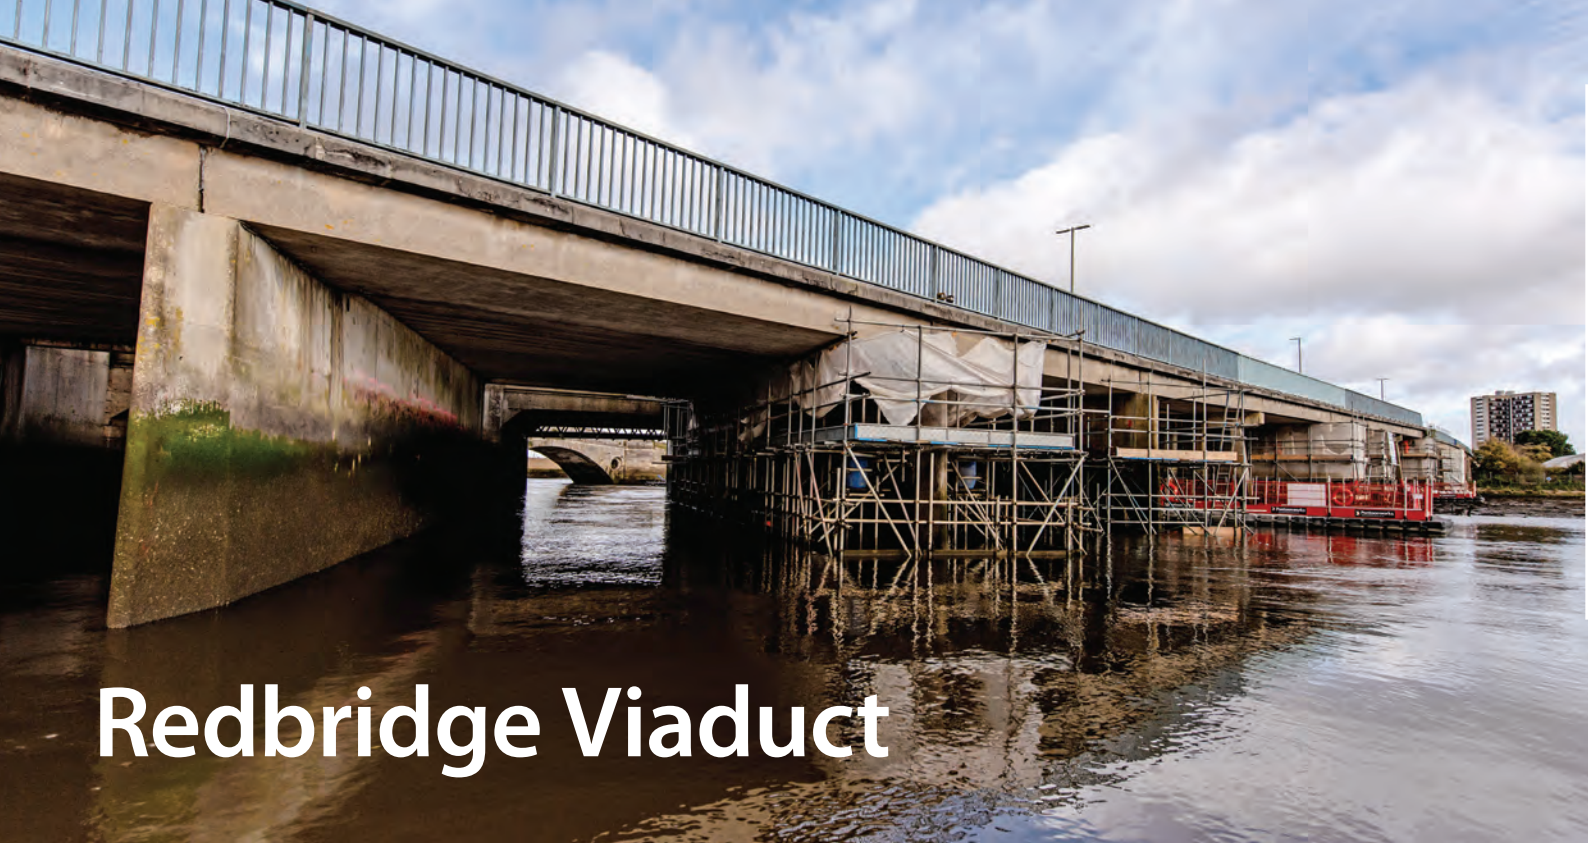
Above: View of causeway leaf piers 17 and 18 scaffolded, with further bents scaffolded.

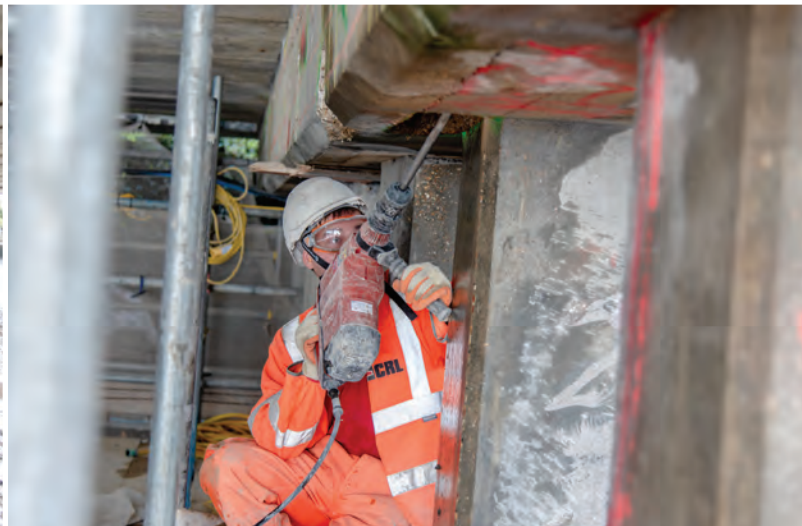
CRL breaking out repairs on bent.

The column beam bents were accessed using independent scaffolds founded on the ground. The works needed to be very carefully undertaken following the detailed repair sequence produced by Atkins. CRL undertook the breaking out with hand-breakers and repaired using hand-placed repair mortar, working around tides. Some

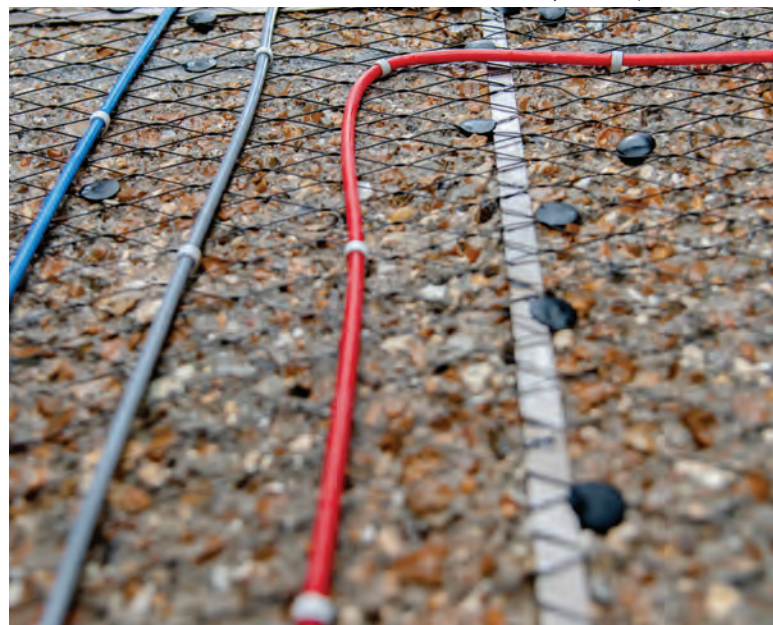
CP mesh overlay on leaf pier.

anode mesh to the face of the piers using plastic fixings. The mesh was welded to the primary anode that was joined to the positive feed cable, which ran back to the junction box at the top of the piers. Six negative connections, plus a further four test negatives were welded to reinforcing bar to form the negative circuit and again taken to the junction box.

The overlay 25/30mm of Renderoc DS dry spray was sprayed over the installation, again using rapid-set for the tidal areas, following sign-off of the installation and saturation of the substrate. Multi-core cables join the junction boxes together and these run the length of the viaduct back to the TR boxes, which have been established either end of the viaduct.

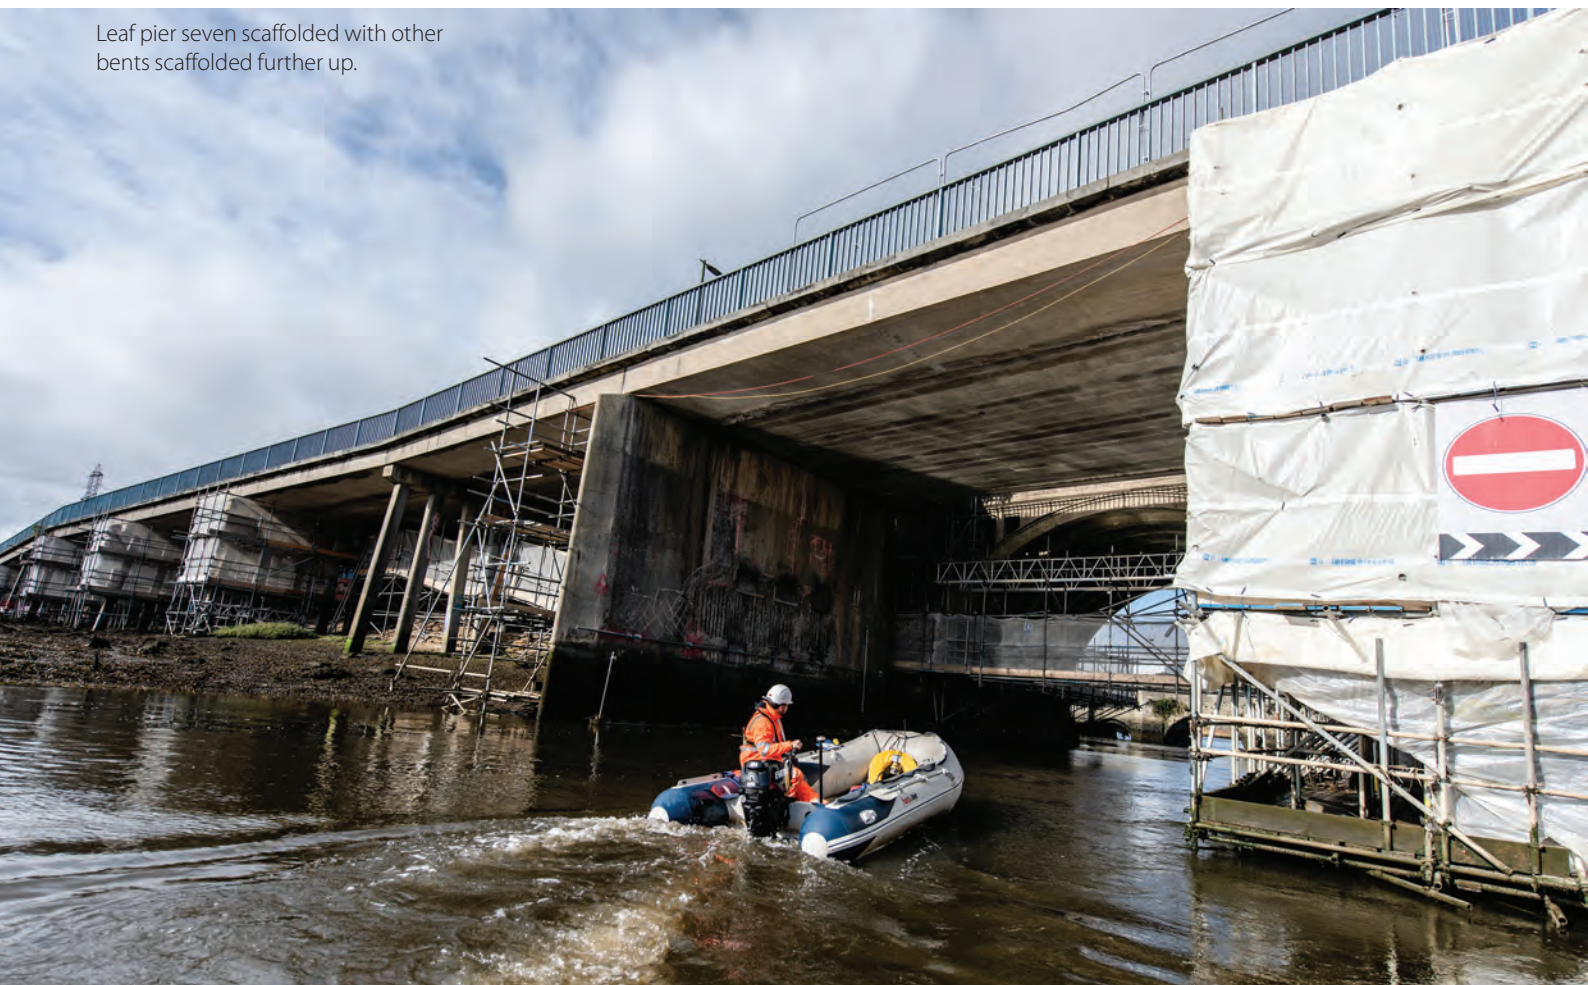
Leaf pier seven scaffolded with other bents scaffolded further up.
