An incident recently occurred when a small amount of hydrodemolition debris flew through the air and passed through a protective barrier damaging a moving vehicle on the public highway.

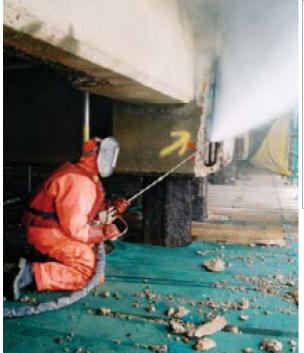
Left: Hydrodemolition (stock photo)

Right: Suggested protection design including one layer of Monarflex and two layers of debris netting.

Hydrodemolition protection must be designed and maintained to prevent ejected material from leaving the work area (see sketch above).
