Safety Alert – Car Park Cable Damage

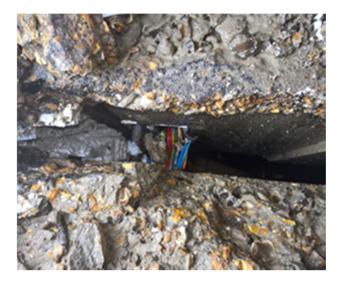
Hydrodemolition contractors recently damaged lighting cables whilst breaking out concrete within a busy, public multi-storey car park.

The cables were within a duct that had been cast within the concrete deck. The client, Principal Designer, Structural Designer, Principal Contractor and their contractors failed to identify the presence of services.

There were no injuries, but there was property damage and disruption as the car park lighting was put out of action.

Before breaking into concrete we need to make enquiries, observations and may need to do a CAT scan to establish the presence or absence of services.

In a car park (for example) if there is lighting, barriers and ticket machines were do the cables run? Can you see conduit or is it hidden within the structure?
