ALERT GRINDER INCIDENT

An CRL employee suffered a severe cut to his face whilst using an angle grinder.

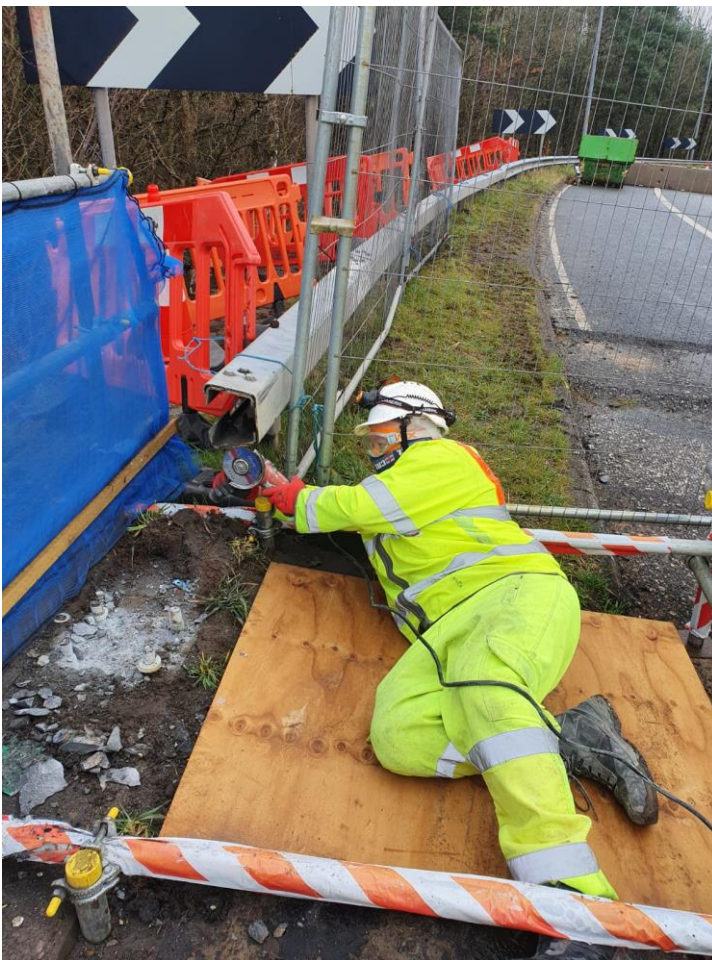
The employee was removing crash barriers. Part of his work involved the cutting of steel security plates that connected the barrier.

The employee was cutting the plate, from a prone position, when he lost control of the 5" grinder and the rotating blade struck his face.

Photo - Reconstruction of the employee's working position whilst cutting the steel plate

- Small plant training should be provided with information and practical instruction on the use of hand-held power tools.
- PPE (face shields) with suitable impact resistance (to BS EN 166 (B)) must be worn when cutting metal.
- Operatives must be reminded that if circumstances on site change from what was envisaged within the safe systems of work, if they feel the operations are unsafe or if they believe there may be a safer way to carry out the operations then they must stop work and report their concerns or suggestions to their supervisor.
- The daily pre-shift briefing must cover specific risks and controls likely to be met on that shift.
- These points should be communicated by toolbox talks and leader's safety tours.
