| <b>ALERT TOPIC</b> | Pressure Washer Hose Failure - High Potential Facial / Eye Injury | <b>ALERT REFERENCE:</b> | CRL |

### INTRODUCTION

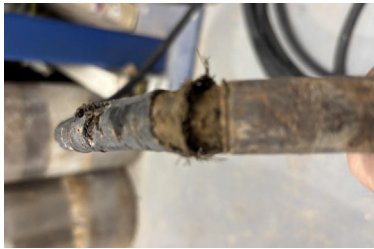
When the pressure washer was started and the system became pressurised, the supervisor noticed a leak approximately 50 mm from the hose connection. As he moved closer to establish whether the leak was coming from the hose or the connection, **the hose suddenly failed under pressure and struck him on the left side of the face, close to his eye.**

As part of its investigation, **Speedy identified that the extension hose was in very poor condition, with the metal reinforcement visible through the outer covering.** Speedy also confirmed that a **used hose had been fitted because a new replacement was unavailable and that no function test had been carried out after the hose was fitted.**

- All hired plant, hoses, fittings and connections must be visually checked before use. **Do not use equipment that is worn, damaged, leaking or of doubtful condition.**

- Pressure hoses are safety-critical components. **Visible reinforcement, damaged outer coverings or leaks require immediate isolation.**
- Where a hose or connection has been fitted or replaced, **a function test must be completed before the equipment is released for use.**

- If a leak is identified while equipment is pressurised, **shut the equipment down and safely release pressure before approaching or handling the hose.**
