Safety Alert – Dropped Tube

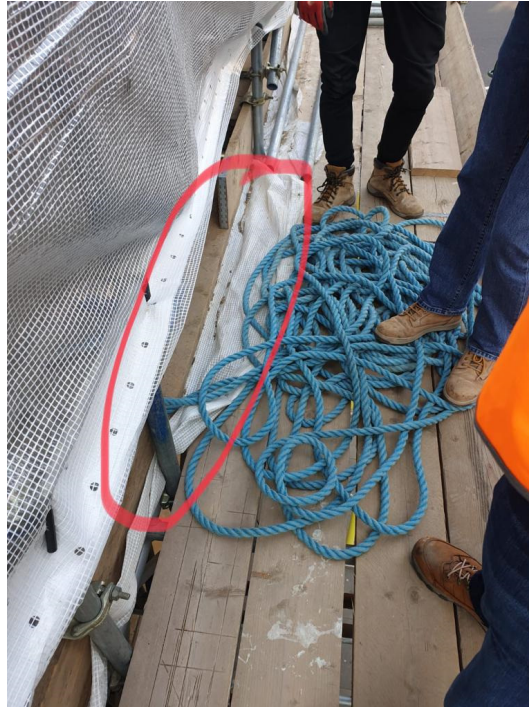
A recent near miss occurred when a short scaffold tube fell 3m from a scaffold platform to a busy high street below. The 300mm length of scaffold tube rolled and fell through a gap in the protective fan. Fortunately no one was injured.

The tube fell through a gap whilst scaffold adaptations were taking place.

On investigation it was found that the scaffold fan had not been constructed in accordance with the scaffold design drawings and it was not double boarded.

Action: During scaffold inspection ensure that there are no gaps that materials or other items could fall through and ensure that housekeeping is maintained.
